CIA/PIR-77073

CIA IMAGERY ANALYSIS DIVISION

PETROVKA SHIPYARD

PETROVKA, USSR

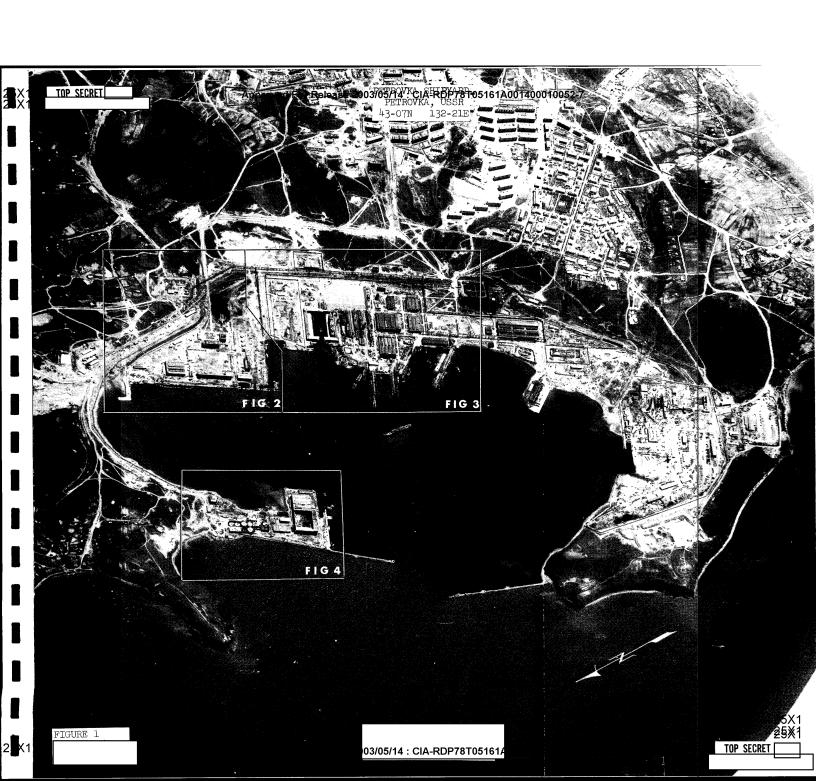
Approved For Religion 30030511 : CIA-RDP78T05161A001400010052-7
	CIA/PIR-77073
	CIA IMAGERY ANALYSIS DIVISION
LOC	PYARD : PETROVKA SHIPYARD ATION : PETROVKA, USSR COORDS: 43-07N 132-21E
	KEY TO FACILITY ANNOTATIONS ON FIGURE 2
Α.	Possible administrative-type building approximately five stories high. Two square raised structures, possibly equating to elevator shaft housings, are visible on the roof of this building.
В.	Unidentified building approximately four stories high. The side of the building furthest away from the quay has the intersection of the roof and side indented along its entire length.

C.	Large round structure. Imagery resembling two black lines bisect each other at right angles across the top of this structure.
D.	Unidentified step-roofed building. Two stacks can be seen on the east end of the lower step.
Ε.	Construction continues on quay area.
	NOTE: The structures (annotations A, B, C, and D) are duplicates of a similar complex near the new wet basin at Yagry Island, Severodvinsk, USSR (64-35N 039-50E). The only difference between the two installations is that the round structure (annotation C) and the step-roofed building (annotation D) are at 90 degrees to the other 2 buildings at Petrovka (probably due to land limitations), whereas the 3 buildings and the round structure are in a straight line at Severodvinsk. The installation at Severodvinsk also has imagery possibly equating to pipes connecting all four units; such a connection is not found at Petrovka. The step-roofed building at Severodvinsk (equating to annotation D at Petrovka) has a series of small raised possible ventilators protruding from the upper step which are not found at Petrovka. Construction on the installation at Petrovka began in approximately

7	
1.	Flooded transporter dock. See annotation 1,

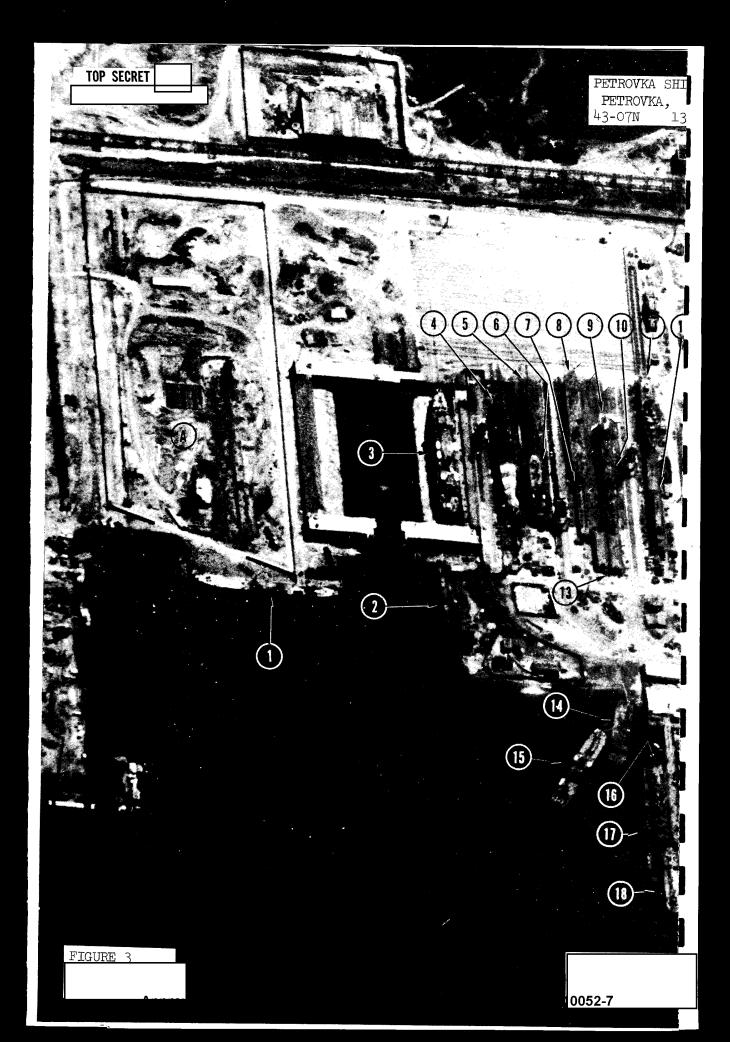
KEY TO FACILITY ANNOTATION ON FIGURE 3

A. Construction area.

Earth scarring is evident in this area. Temporary construction roads and large cranes are present. Footings are in place adjacent to one of the large cranes. Small construction sheds or piles of materials are also visible. A fence surrounds the entire construction development except for the portion near the quay.

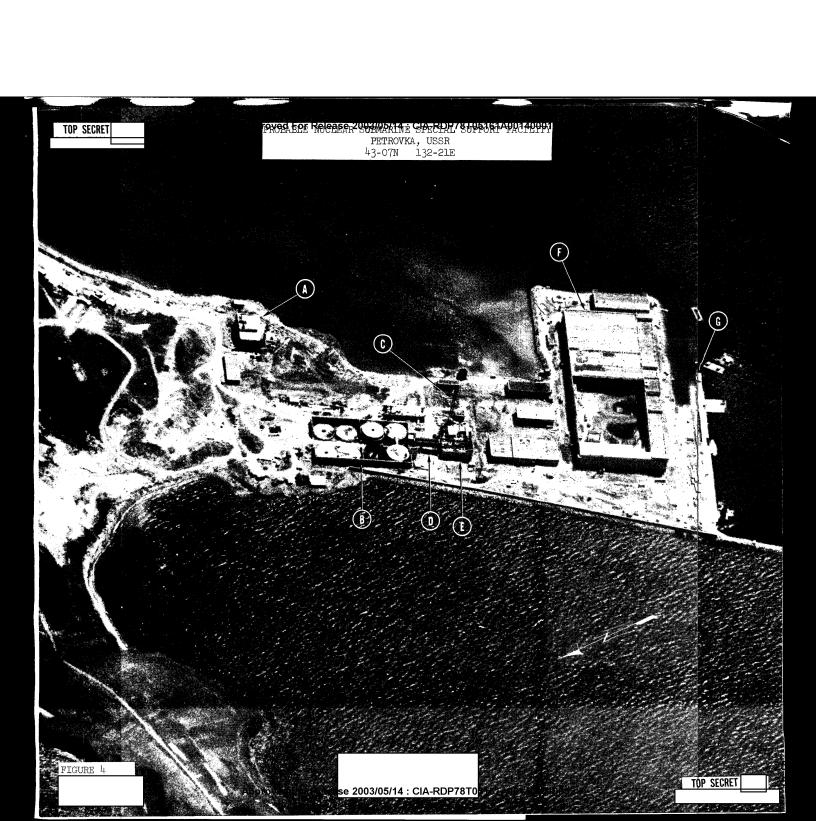
CIA/PIR-77073					
	CIA IMAGERY ANALYSIS DIVISION					
LOC	IPYARD : PETROVKA SHIPYARD CATION : PETROVKA, ÜSSR COORDS: 43-07N 132-21E					
	KEY TO FACILITY ANNOTATIONS ON FIGURE 4					
Α.	Possible administration-type building under construction. The roof on this building is not yet completed. A similar building is observed to the south of the repair ways on Figure 1. The same type building is also observed at Yagry Island, Severodvinsk, USSR. A portal crane is observed operating alongside the building. (See annotation A,					
В.	Tank housing structure. The building is divided into two sections with accommodations for four tanks in each section. Three of the four tanks in the southern portion of the building are in a late stage of construction. The fourth tank has its sides erected and a large post in the center. The top of the tank is not in place. The bases for the four tanks in the northern end of the building are still under construction.

С.	The boom portion of a very (high) large crane is visible behind the probable processing building.					
D.	Bridge connecting the tank housing structure with a probable processing building. This bridge may contain piping between the two structures; if so, it is believed such piping would carry liquid waste. See annotation A,

E.	Probable processing building. When compared to its counterpart at Severodvinsk, this structure appears to be only half as high; however, construction on the processing building at both sites is still continuing. See annotation A,

F.	Main building. Approximately 50 per cent of the roof of the main building has been completed.					
G.	Work continues on the quay with probable pile drivers working just off- shore. For the last observation of this facility see annotation A,					
	<u> </u>

NOTE: The Petrovka facility is now approximately two years in construction behind the facility located at Yagry Island, Severodvinsk, USSR.

This facility appears to now be in the same status of was Severodvinsk
